# Reserve Fund Analysis Report

*Update Study With Site Visit*  
**Grand View Villas HOA**  
**Grand Lake, CO**

Report #:	9173-2
Inspection Date:	April 29, 2022
For Year Beginning:	January 1, 2023
For Year Ending:	December 31, 2023
Date Prepared:	August 21, 2022
Prepared by:	Richard Hamilton RS, PRA
Report Status:	<b>Draft - REV2</b>

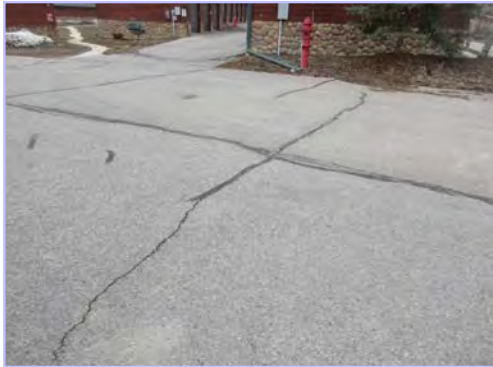
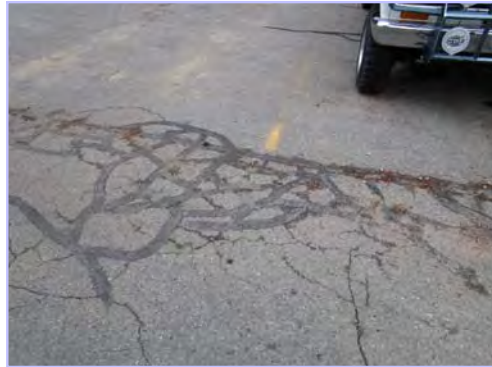
Asphalt areas appeared in overall fair condition throughout with some noted cracking from settling in several areas. Plan on regular cycles of seal and repair after resurface project, which is recommended for maximum design life. As part of routine maintenance, keep surface clean and free of debris, ensure that drains are free flowing, repair cracks and clean oil stains promptly.

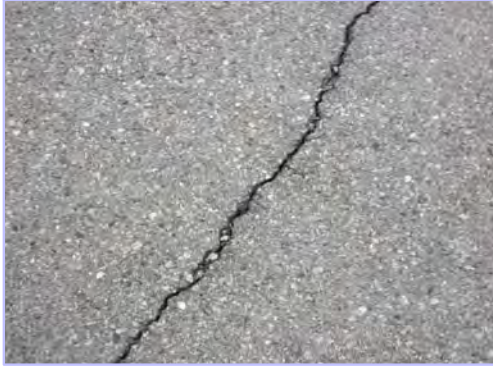
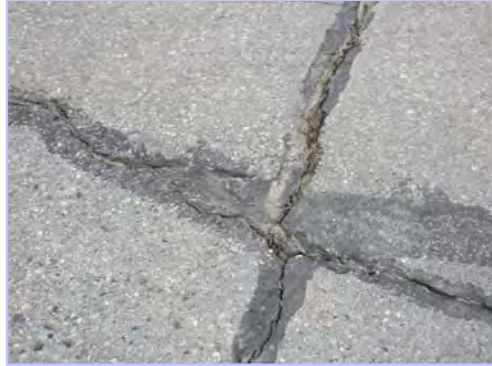
Recommend regular inspections and crack/fill work to mitigate any subsurface moisture. Subsurface moisture and loads typically contribute to accelerated deterioration. Also, timing (what month work is performed) is important in determining when crack/fill work should be completed, in order to take advantage of maximum shrinkage (expanding crack) and workability of materials.

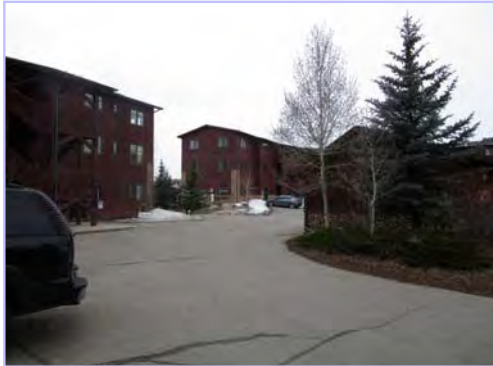
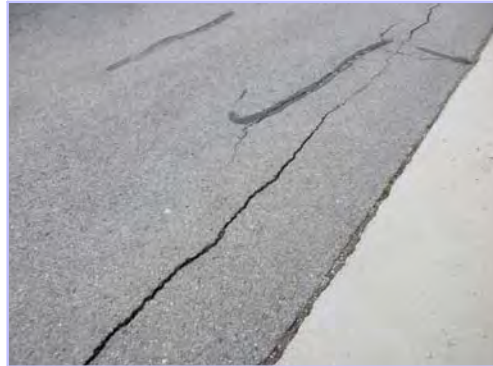
Asphalt surface is in overall fair condition, but is extremely dry with several area of cracking. Plan on a regular application of an impervious surface treatment for the long-term care of asphalt paving. The primary reason to seal coat asphalt pavement is to protect the pavement from the deteriorating effects of sun and water. When an asphalt pavement is exposed to sun, wind and water, the asphalt oxidizes (hardens). This causes the pavement to become more brittle. As a result, the pavement will crack because it is unable to bend and flex when exposed to traffic and temperature changes. A seal coat combats this situation by providing a barrier which not only slows down the oxidation process, but also helps the pavement to shed water, preventing it from entering the underlying base material. Seal coat also provides uniform appearance, concealing the inevitable patching and repairs, which accumulate over time. Seal coat ultimately extends useful life of asphalt, postponing the asphalt resurfacing, which can be one of the larger cost items in the reserve study. See previous component for asphalt resurfacing costs. Repair asphalt before seal coating. Surface preparation and weather, during and following application, is key to lasting performance. Installations of seal coats are affected greatly by weather conditions. The ideal conditions are a warm, sunny day with low humidity. Rain or snow can cause major problems when seal coating. Seal coating should never be done when showers are threatening. Apply two coats or flood application of a quality asphalt emulsion. Fill cracks and clean oil stains promptly in between cycles as routine maintenance.

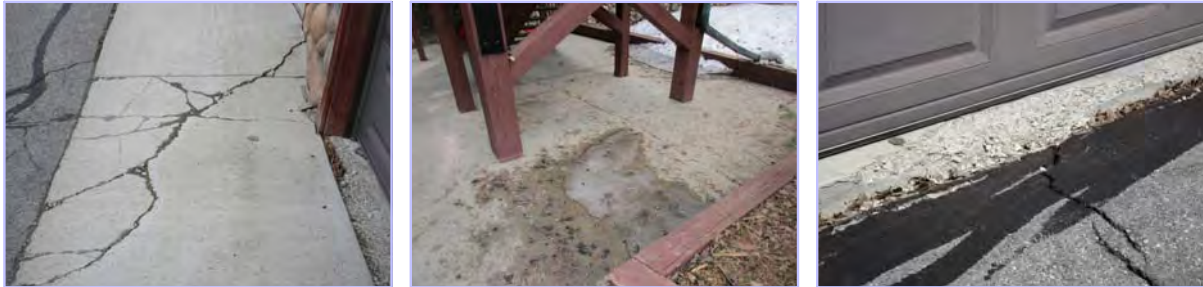
Concrete ranges from good to fair condition with some noted areas of cracking and chipping. A replacement project at the front of building 1 is planned for 2022. The garage bibs and garage slabs have experienced significant deterioration due to water run-off and repeated freeze thaw cycles. Funding anticipates replacing the bibs (360 SF) as well as a portion (720 SF) of the garage slabs. Recommend repairing any trip/fall hazards immediately and inspect concrete regularly for any damage. Repair and replace concrete to mitigate any subsurface moisture which will accelerate deterioration. Funding is to replace sections of concrete as needed, with no anticipation of replacing all concrete at one time.

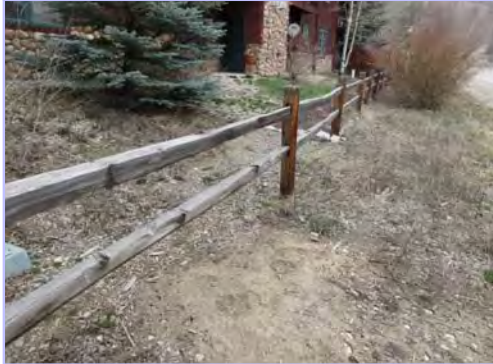
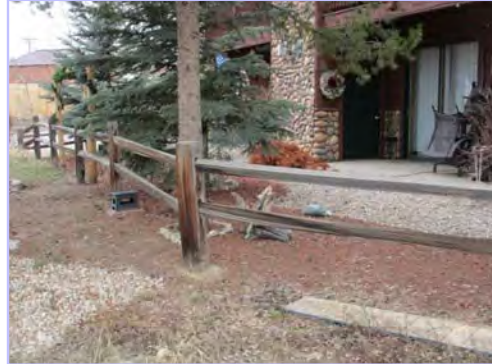
The wood rail fence is in good to fair condition with limited signs of damage, but some noted weathering. Funding is based on maintaining fence by periodic sealing or staining. Recommend periodic inspections to identify and treat damaged areas in order to avoid more costly repairs in the future.

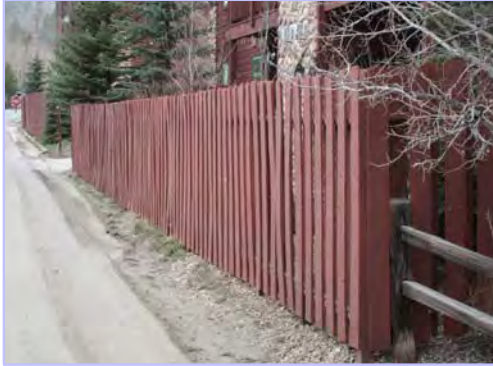
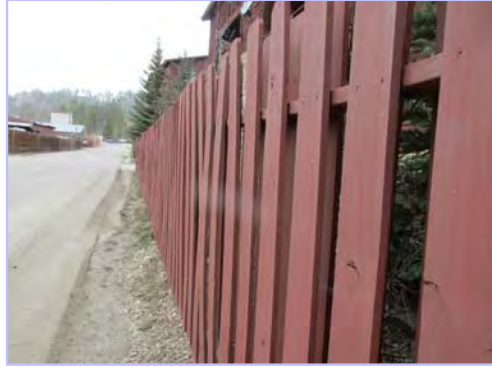
The wood fence ranges from good to fair condition with some signs of fading, cracked, and warped boards and loose nails. Useful life may vary by integrity of posts (how well they are secured), and exposure to the elements.

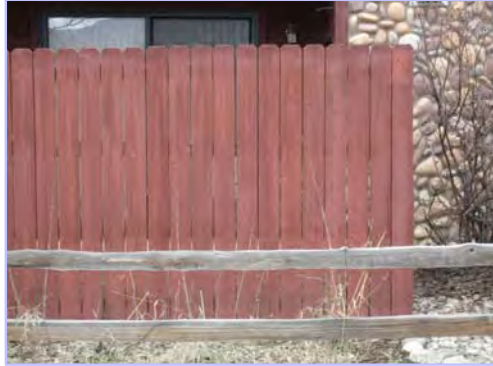
Wood fence is in overall good to fair condition with some limited signs of fading and wear. Recommend the regular application of a quality wood surface stain or sealer to protect the wood from the elements.

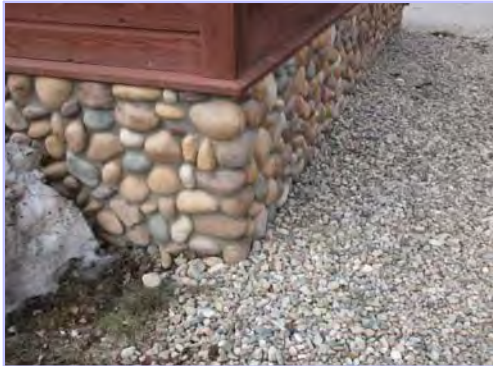
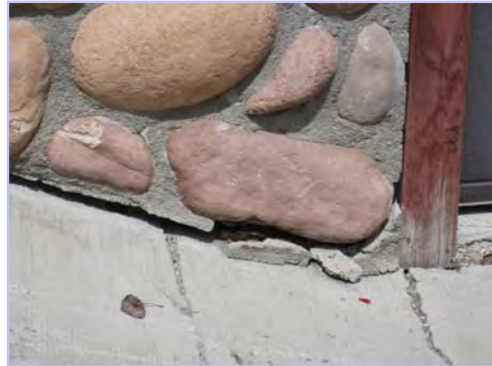
Rock veneer is in overall good condition with minor areas of cracked grout. Recommend periodic inspections to ensure grout is intact. Subsurface moisture which exposed to a freeze/thaw cycle will accelerate the useful life of this component. Funding is for periodic repointing of grout.

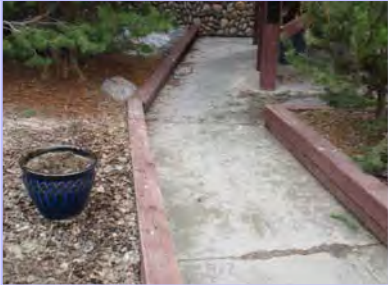
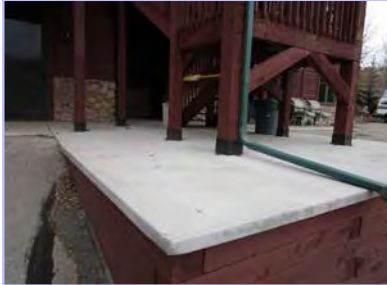
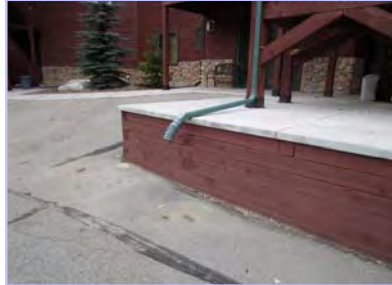
The tie planter boxes and retaining walls are in overall good to condition with some signs of deteriorated wood and minor movement, particularly at building 1. It is anticipate that the wood at building 1 will be repaired in conjunction with the concrete replacement project. Anticipate replacing areas as needed. Areas where ties are used as steps should be monitored closely and any trip and fall hazards should be repaired immediately.

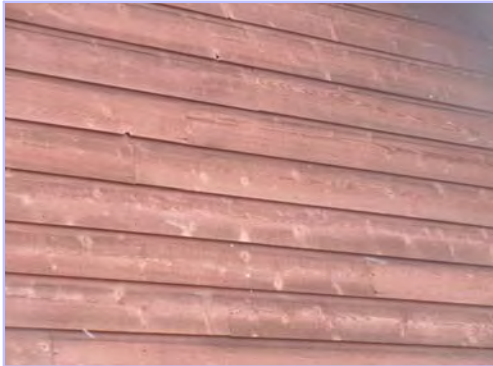
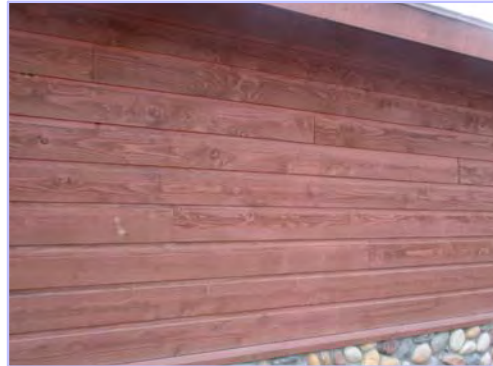
Cedar siding is in good condition with minor areas of fading. Siding, depending on exposure and orientation, is aging differently. Because cedar is readily available, and replacement will not be subject to profile and grain pattern changes as you would find in a manufactured product, replacement is anticipated to be performed on an as-needed basis with no anticipation of replacing all siding at one time. Recommend regular stain and seal to prevent moisture penetration which will reduce the life of this component.

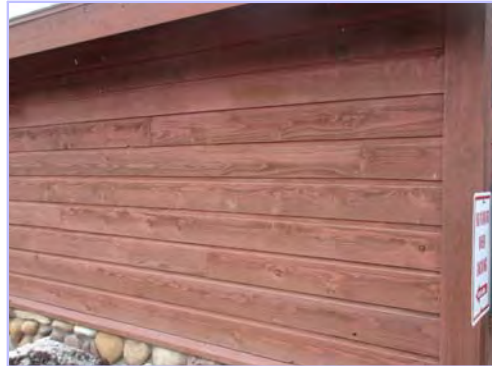
Stain is in generally good condition with some areas showing minor signs of fading. Recommend the application of a quality sealer to protect the wood from the elements. Anticipate projects will be funded as needed with one building completed every other year, so that all buildings are completed every six years. Funding also includes a portion of the garage structures.

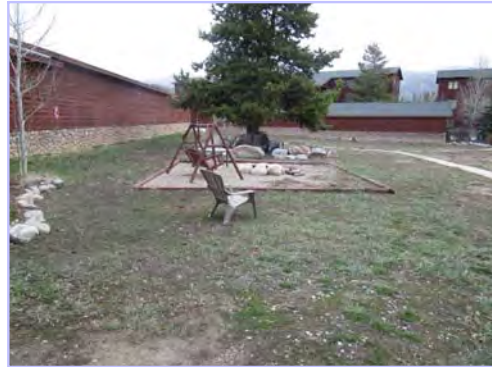
Trees and vegetation appear in overall good to fair condition. Funding is for ongoing replacement of trees and vegetation due to winter kill and disease, as well a general maintenance such as trimming. We recommend consulting a licensed arborist prior to replacing trees.

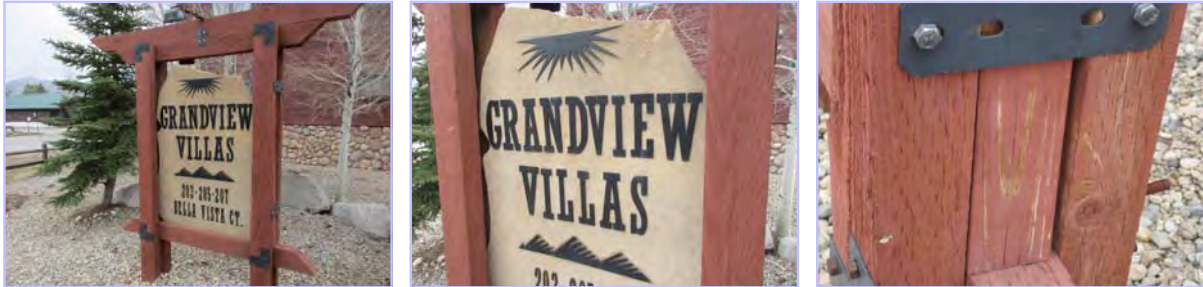
Sign is decorative carved stone with painted lettering. Sign is in good condition overall. Anticipate repairing or refurbishing stonework and lettering on a cyclical basis as well as staining wood in conjunction with building stain projects.

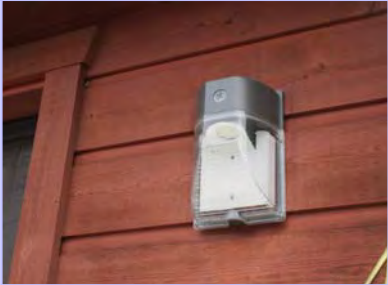
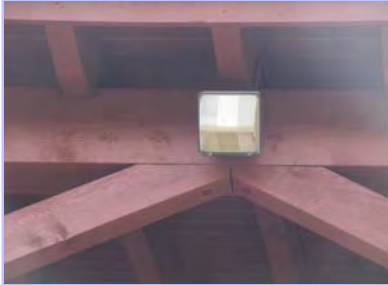
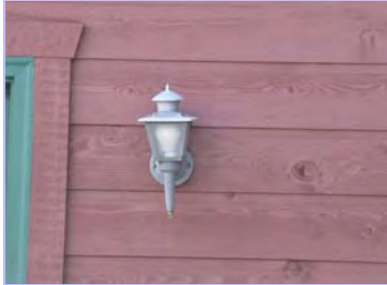
Light inventory includes garage lights, entry, porch lights and miscellaneous fixtures. Anticipate replacing items on an as-needed basis with no anticipation of replacing all items at one time. It appears that some replacement has been completed.

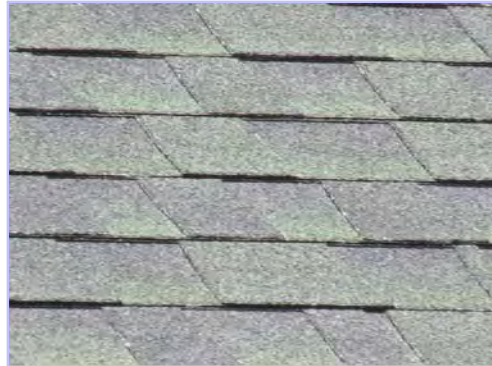
Asphalt shingles on **Building 1** appear in overall fair to poor condition with areas of raised/buckled shingles and some noted granular loss. Roofs appear to be a Tamko Heritage product. Anticipate a shorter useful life than advertised by the manufacturer in all cases due to extreme weather conditions. Recommend yearly inspections by a qualified roofer to ensure roof and flashings are intact and maintained. Funding anticipates the replacement of a portion of the garage roof in conjunction with roof replacement projects. Costs include replacement of roof vents.

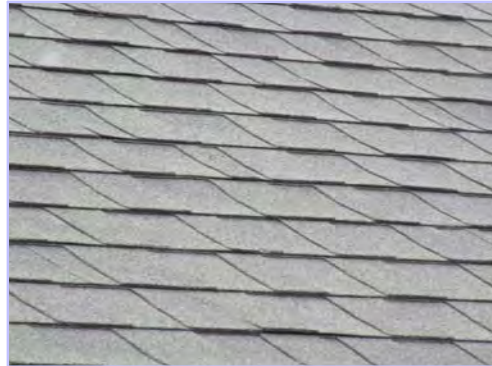
Asphalt shingles on Building 2 appear in overall fair to poor condition with areas of raised/buckled shingles and some noted granular loss. Roofs appear to be a Tamko Heritage product. Anticipate a shorter useful life than advertised by the manufacturer in all cases due to extreme weather conditions. Recommend yearly inspections by a qualified roofer to ensure roof and flashings are intact and maintained. Funding anticipates the replacement of a portion of the garage roof in conjunction with roof replacement projects. Costs include \$16,800 for the replacement of 12 roof vents.

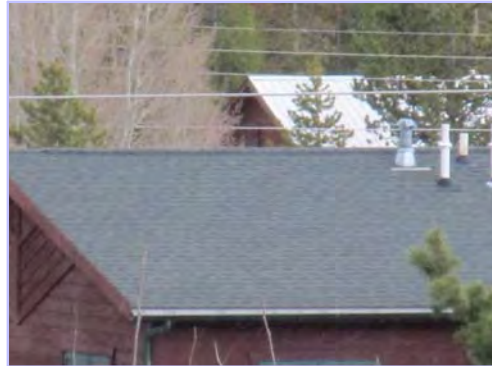
Asphalt shingles on Building 3 appear in overall fair condition with areas of raised/buckled shingles and some noted granular loss. Roofs appear to be a Tamko Heritage product. Anticipate a shorter useful life than advertised by the manufacturer in all cases due to extreme weather conditions. Recommend yearly inspections by a qualified roofer to ensure roof and flashings are intact and maintained. Funding anticipates the replacement of a portion of the garage roof in conjunction with roof replacement projects. Costs include \$25,300 for the replacement of 18 roof vents.

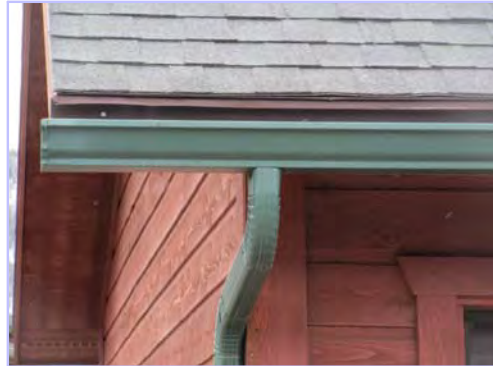
Gutters and downspouts are in overall good condition. Recommend yearly inspections to ensure gutters and downspouts are clean, and repair any leaks or damaged areas. Proper water flow is important to mitigating any fascia damage and ensuring water is directed away from the foundations of the buildings. Funding anticipates replacement in conjunction with roof replacement projects. Funding also anticipates the addition of gutters to the front of all garage building to protect concrete from winter freeze/thaw cycles. Funding anticipates the replacement of a portion of the garage gutters in conjunction with roof replacement projects.

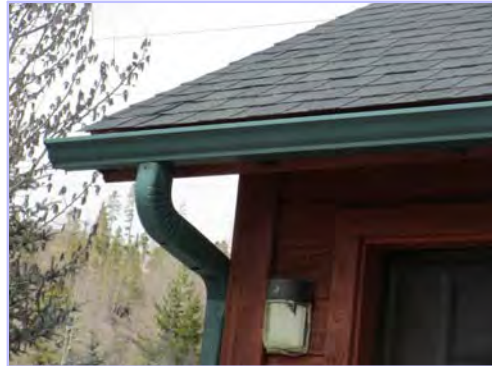
Gutters and downspouts are in overall good condition. Recommend yearly inspections to ensure gutters and downspouts are clean, and repair any leaks or damaged areas. Proper water flow is important to mitigating any fascia damage and ensuring water is directed away from the foundations of the buildings. Funding anticipates replacement in conjunction with roof replacement projects. Funding also anticipates the addition of gutters to the front of all garage building to protect concrete from winter freeze/thaw cycles. Funding anticipates the replacement of a portion of the garage gutters in conjunction with roof replacement projects.

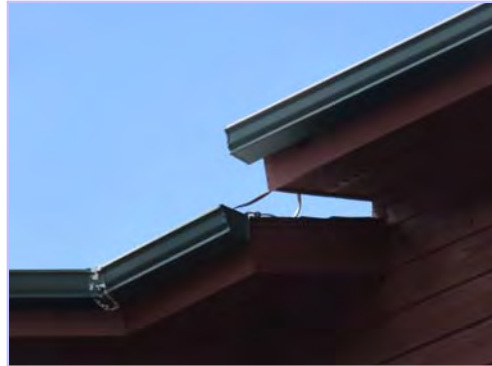
Gutters and downspouts are in overall good condition. Recommend yearly inspections to ensure gutters and downspouts are clean, and repair any leaks or damaged areas. Proper water flow is important to mitigating any fascia damage and ensuring water is directed away from the foundations of the buildings. Funding anticipates replacement in conjunction with roof replacement projects. Funding also anticipates the addition of gutters to the front of all garage building to protect concrete from winter freeze/thaw cycles. Funding anticipates the replacement of a portion of the garage gutters in conjunction with roof replacement projects.

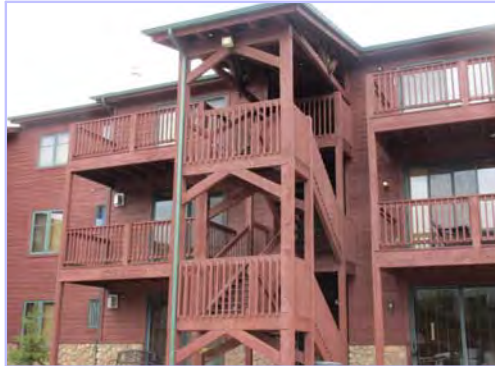
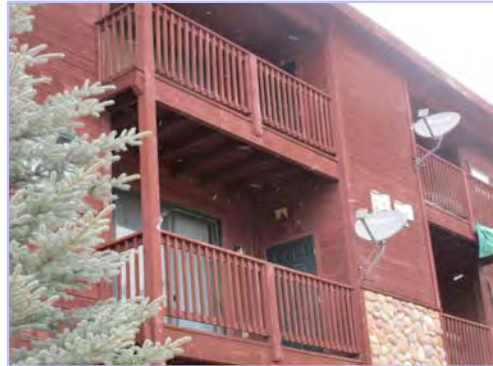
Decks and stairways are in overall good condition with a few signs of shifting and settling. Funding anticipates periodic repairs to level decks and reinforce stairways. This components will need constant evaluation as the community ages and may need adjustment in future reports.

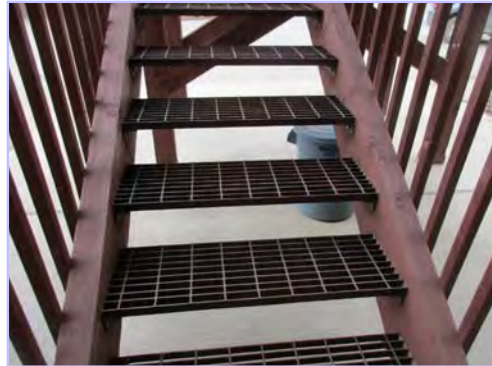
Decks and stairways are in overall good condition with a few signs of shifting and settling. Funding anticipates periodic repairs to level decks and reinforce stairways. This components will need constant evaluation as the community ages and may need adjustment in future reports.

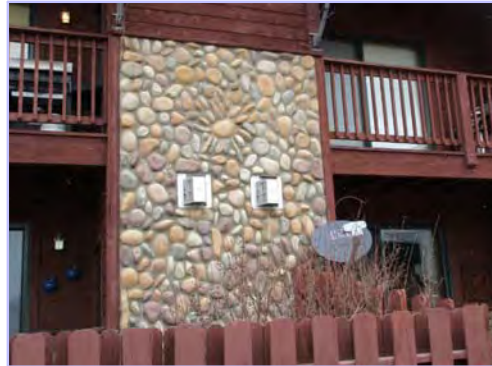
Structurally supported decks are in overall good condition. Funding anticipates periodic repairs to deck surfaces and trusses. This components will need constant evaluation as the community ages and may need adjustment in future reports.

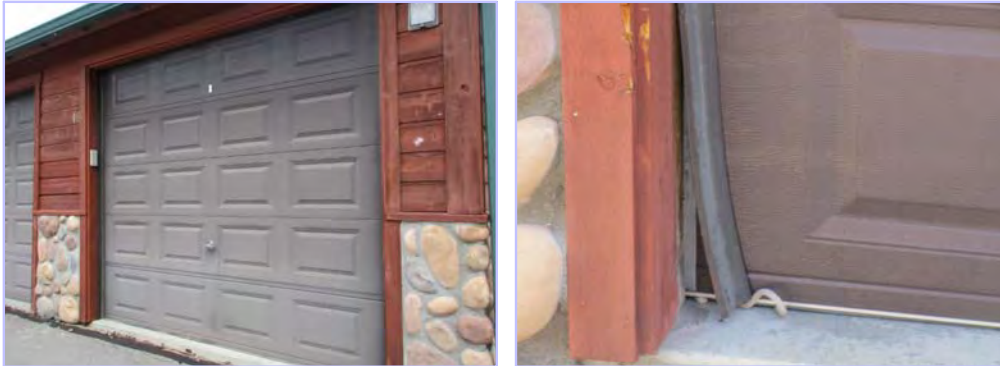
The metal garage doors appear in overall good condition. Anticipate regular painting in conjunction with building staining projects. Plan to replace due to age and use to maintain community appearance.

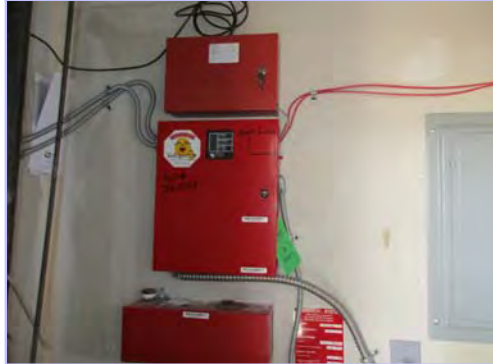
The (3) fire monitoring systems consisting of Silent Knight control panels and enunciators are in overall good condition and working properly. Anticipate replacement as future technologies become available.
